MITIGATION PLAN FOR THE COVE SPRING STREAM RESTORATION PROJECT FRANKLIN COUNTY, KENTUCKY

September 10, 2009

Mitigation Plan for the Cove Spring Restoration Project

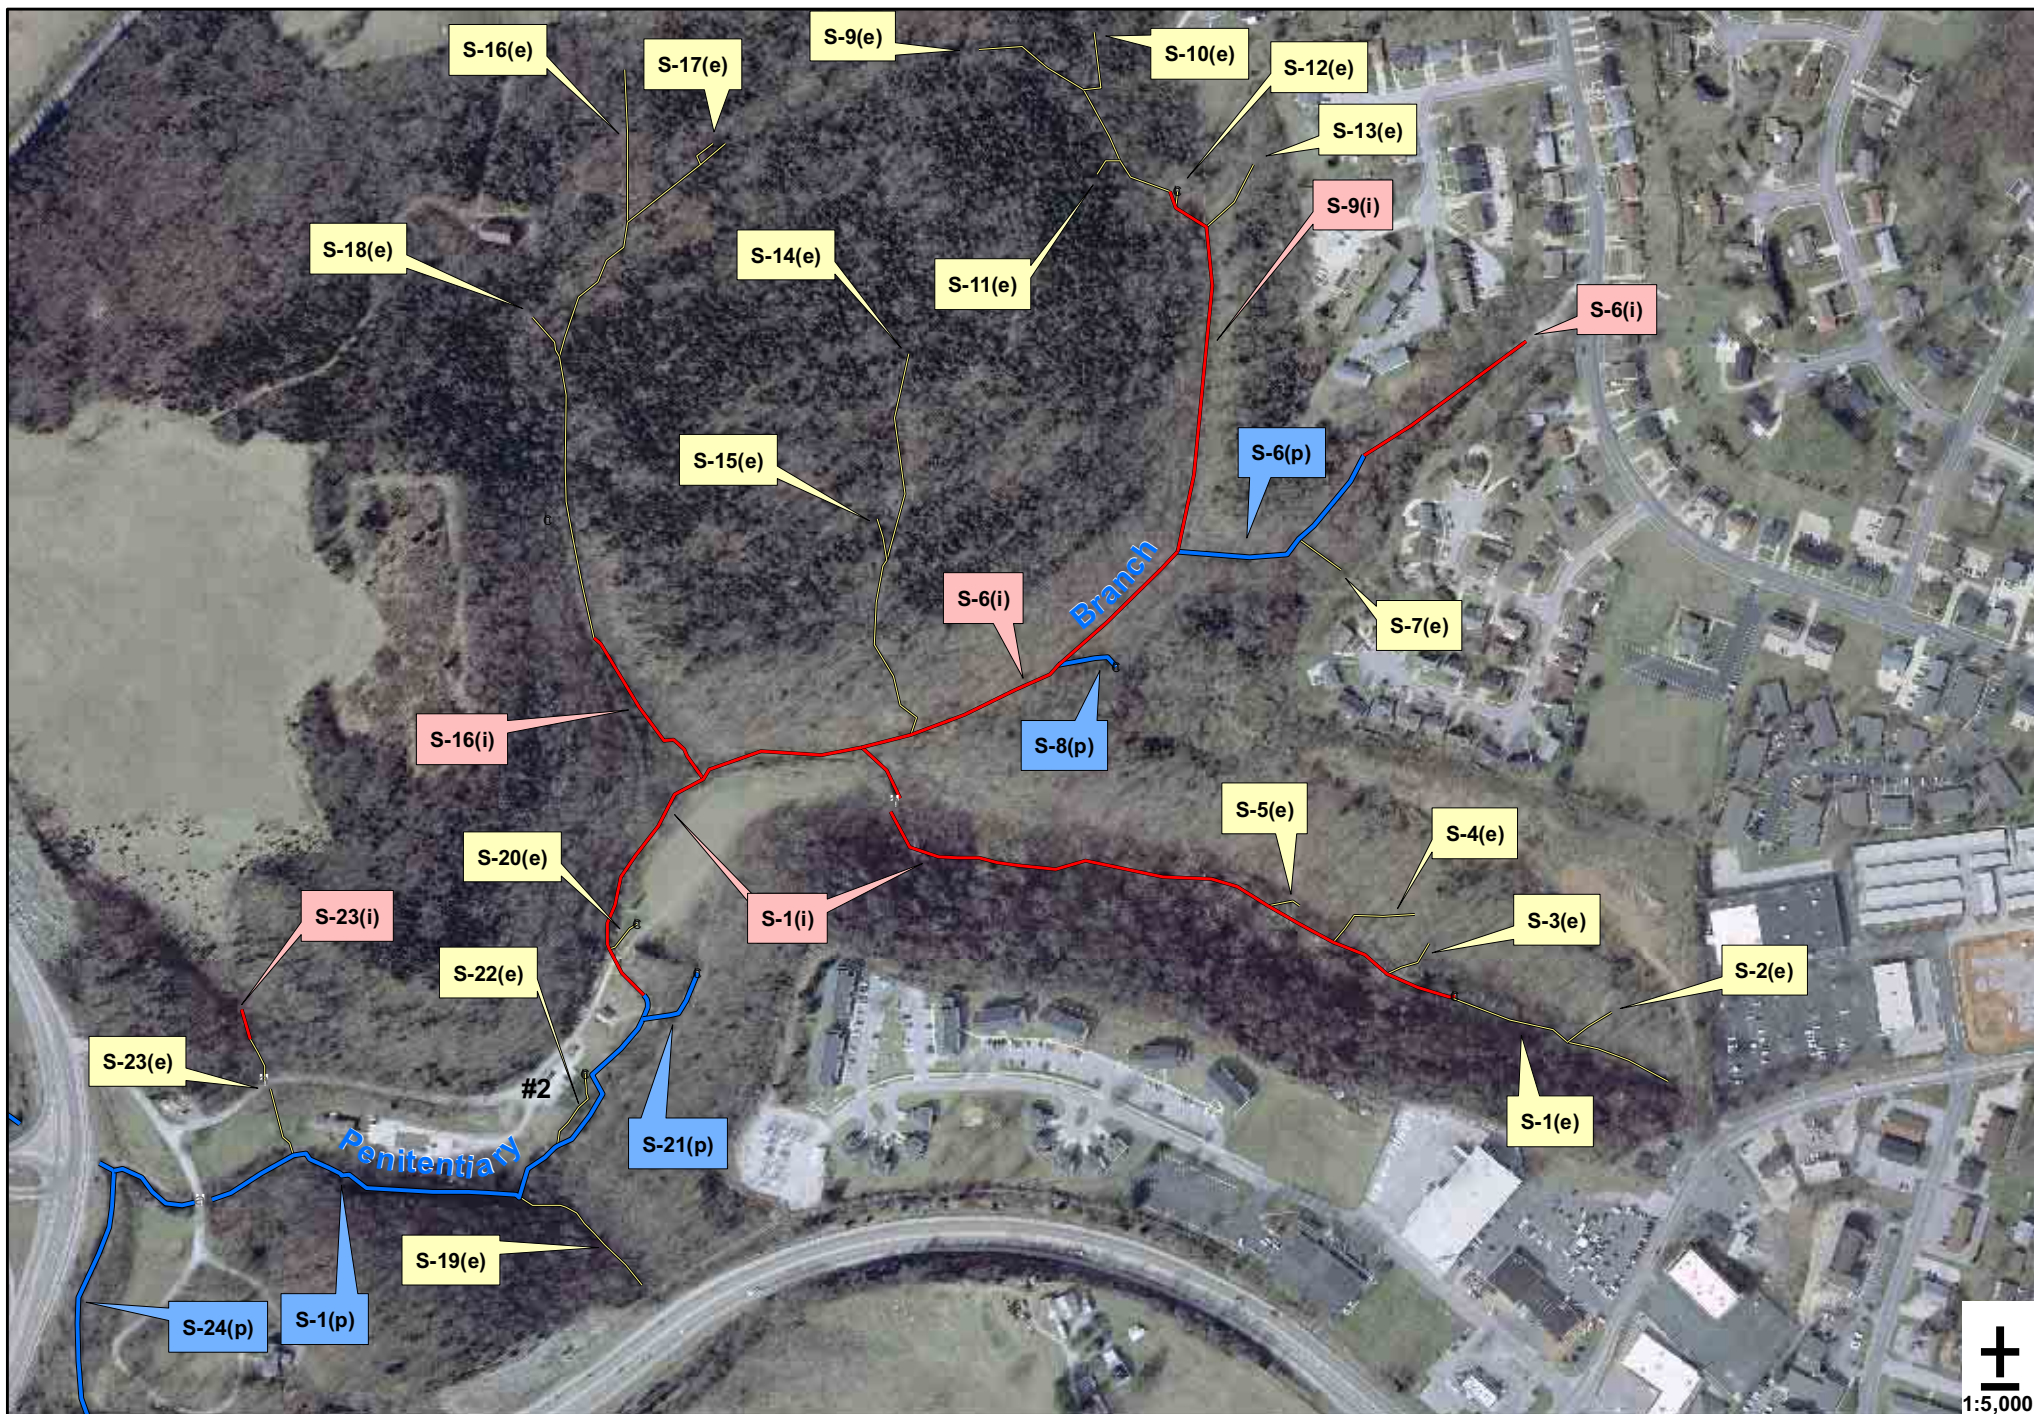
a	Culvert	c	Spring
			Intermittent Stream(i)
			Perennial Stream(p)
			Ephemeral Stream(e)

FIGURE 3a. JWD FEATURES MAP
 Jurisdictional Waters Determination
 for the Cove Springs Stream Restoration Project,
 Franklin County, Kentucky
 FSA 2004 NAIP DOQQ

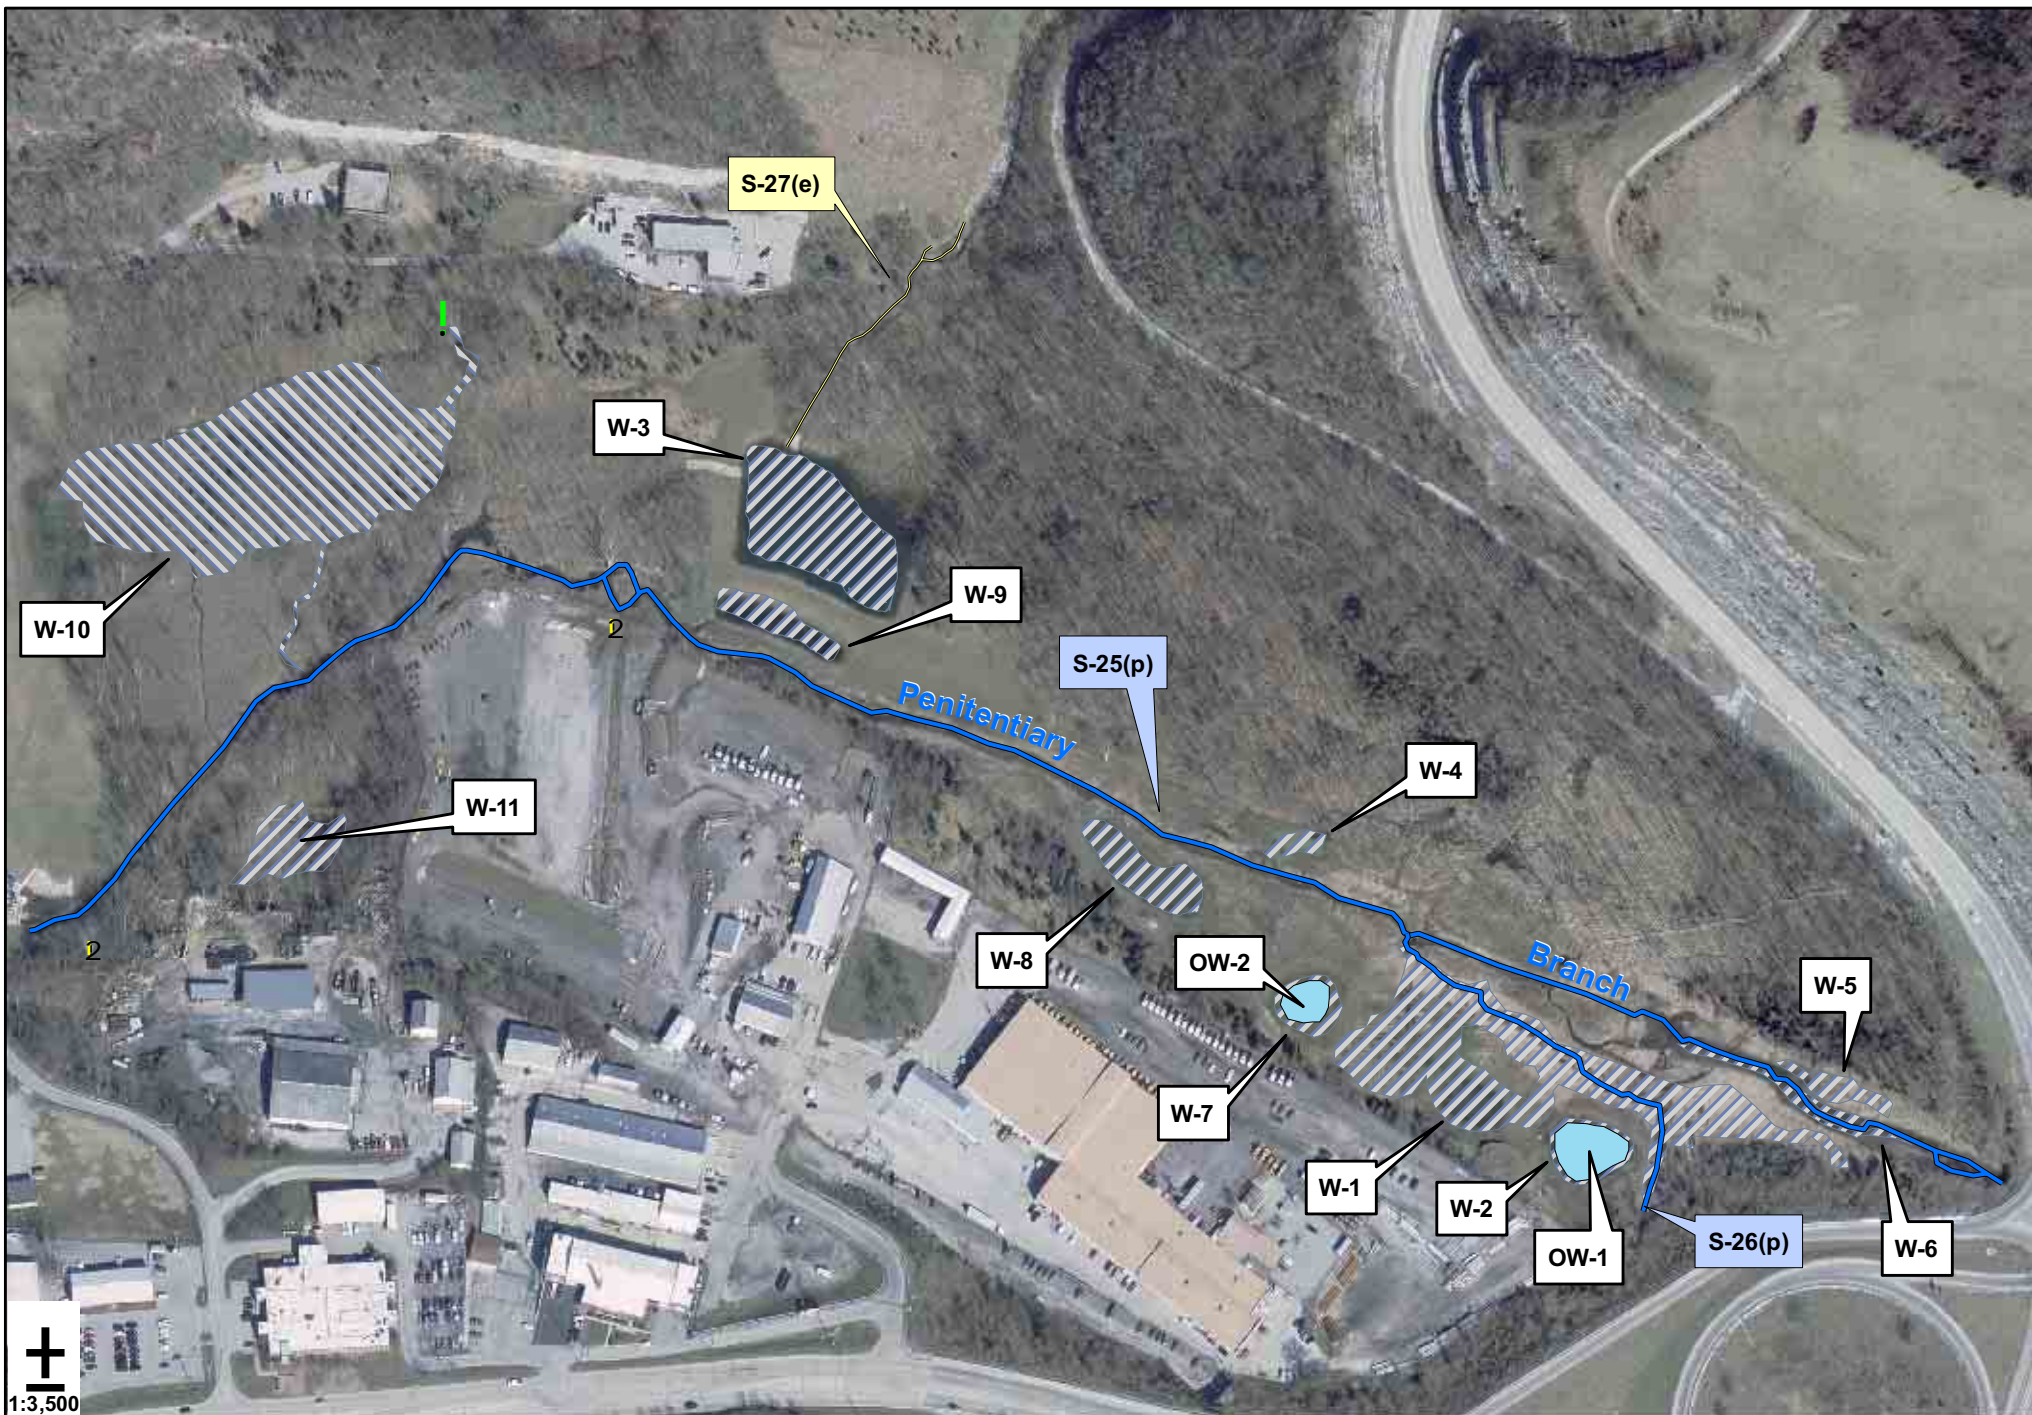
FIGURE 3b. JWD FEATURES MAP
 Jurisdictional Waters Determination
 for the Cove Springs Stream Restoration Project,
 Franklin County, Kentucky
 FSA 2004 NAIP DOQQ

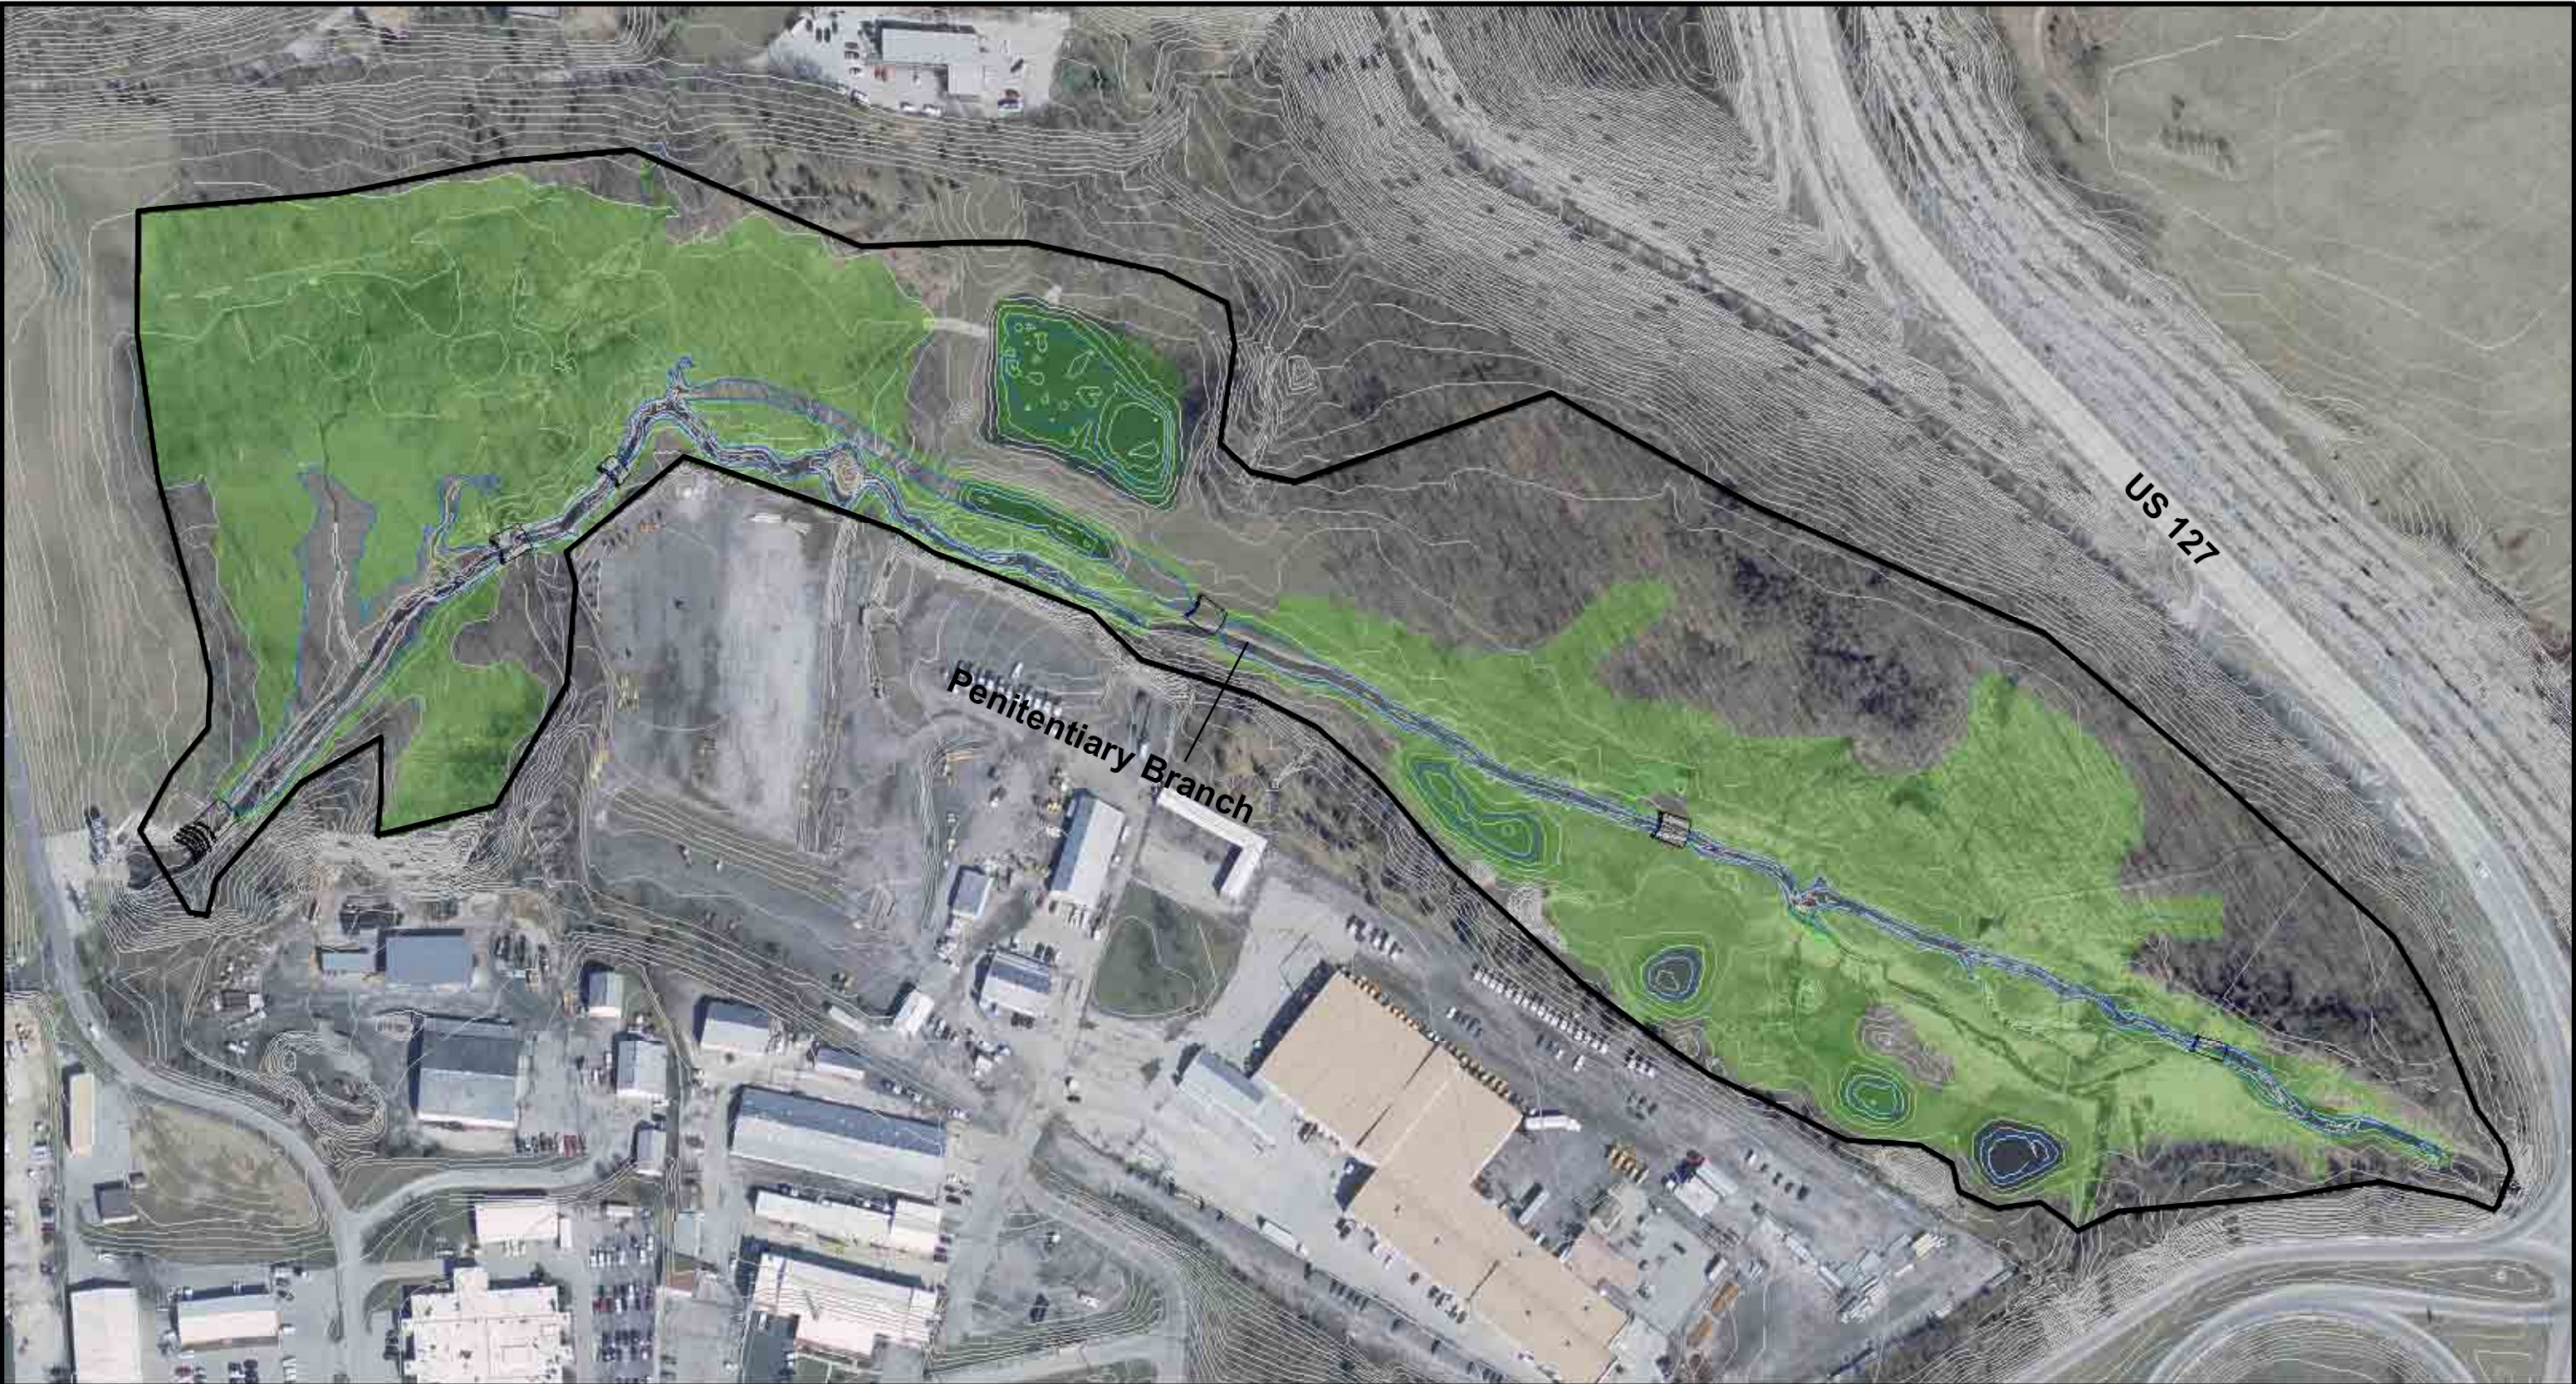
**Cove Spring Stream Restoration
Wetland Creation Areas
Franklin County, KY**

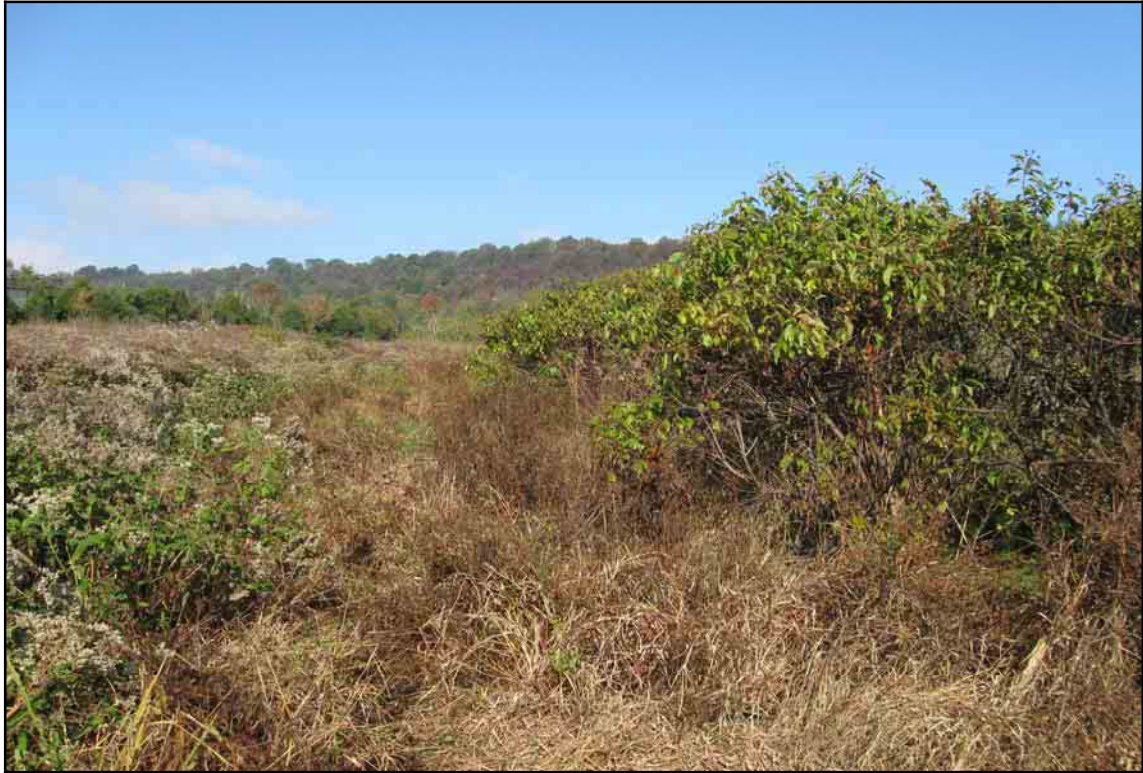
Wetland 1 (W-01) facing west.

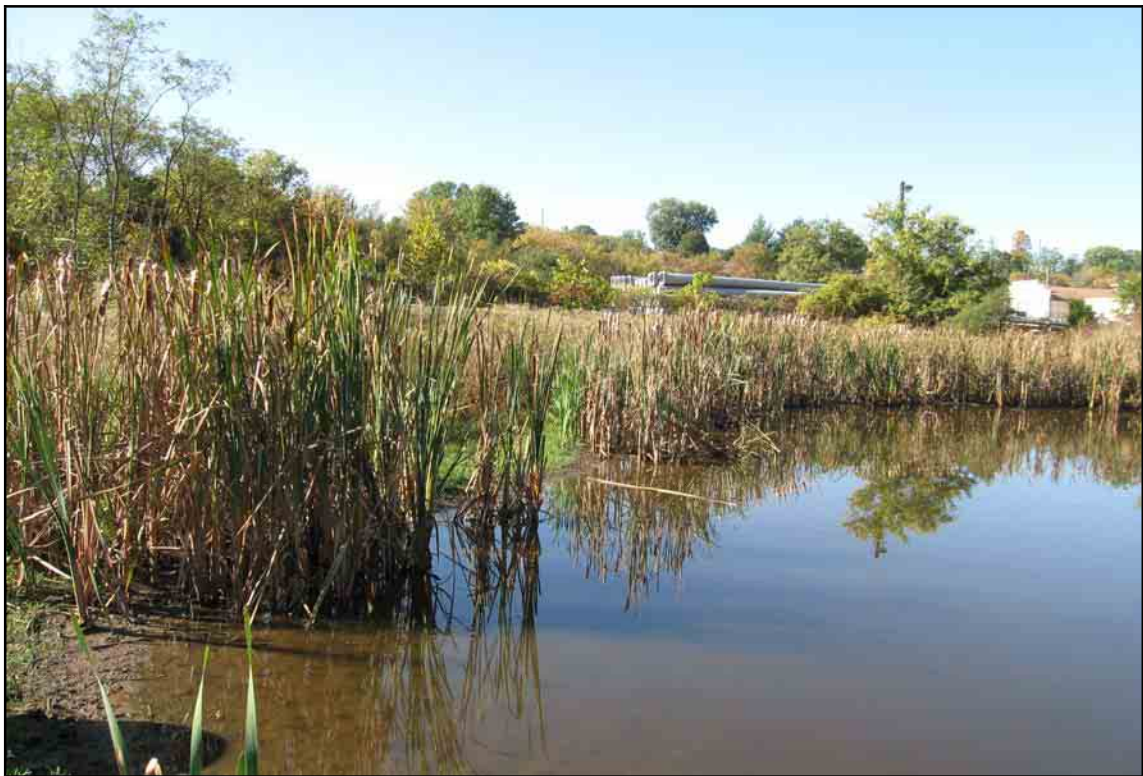
Wetland 2 (W-02) pond margin facing west.

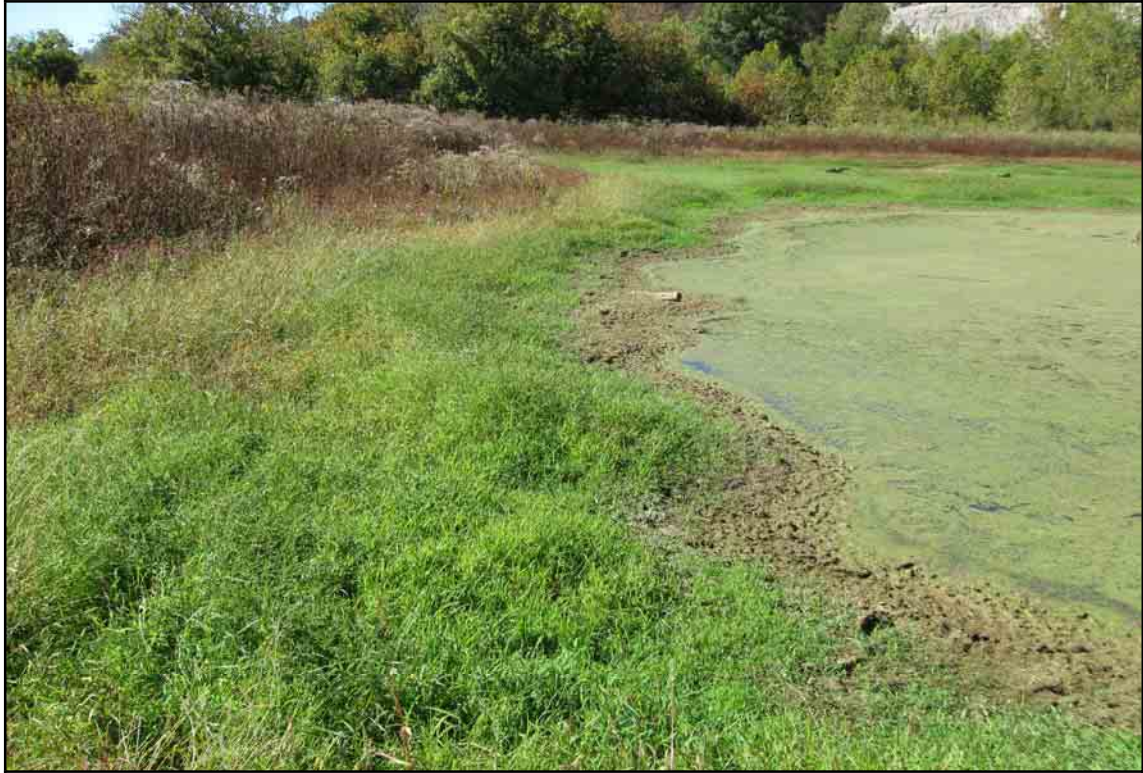
Wetland 3 (W-03) facing west.

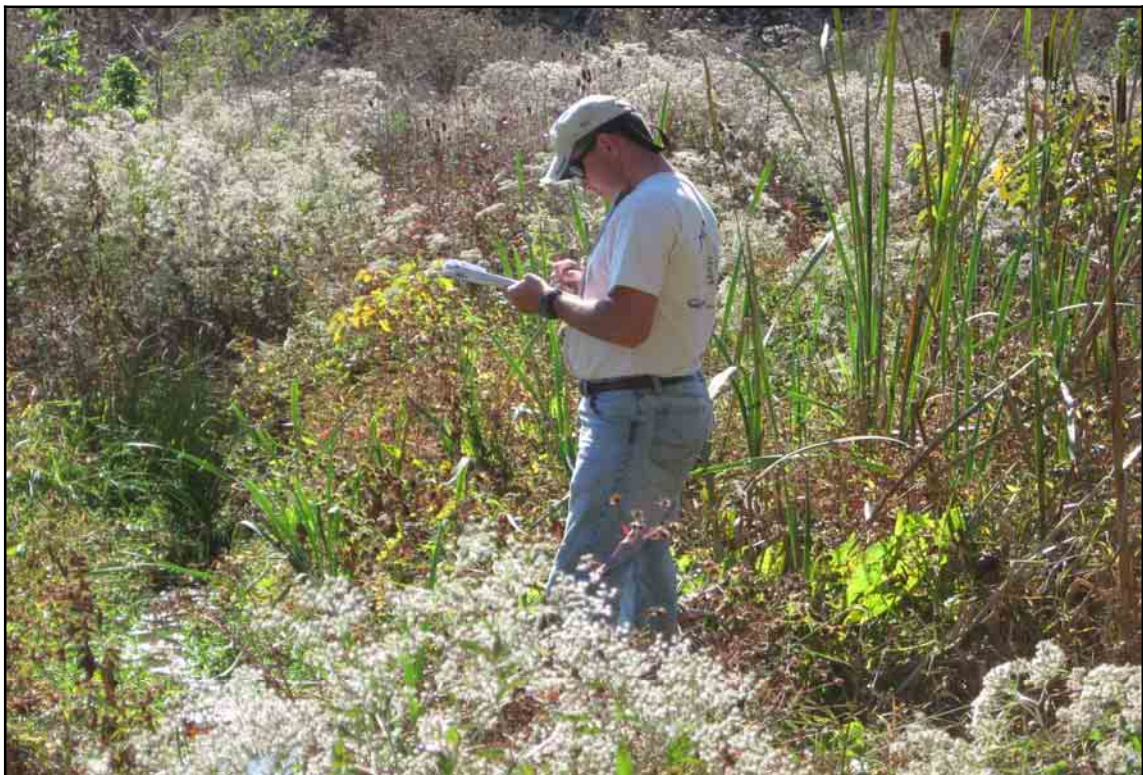
Wetland 4 (W-04) facing south.

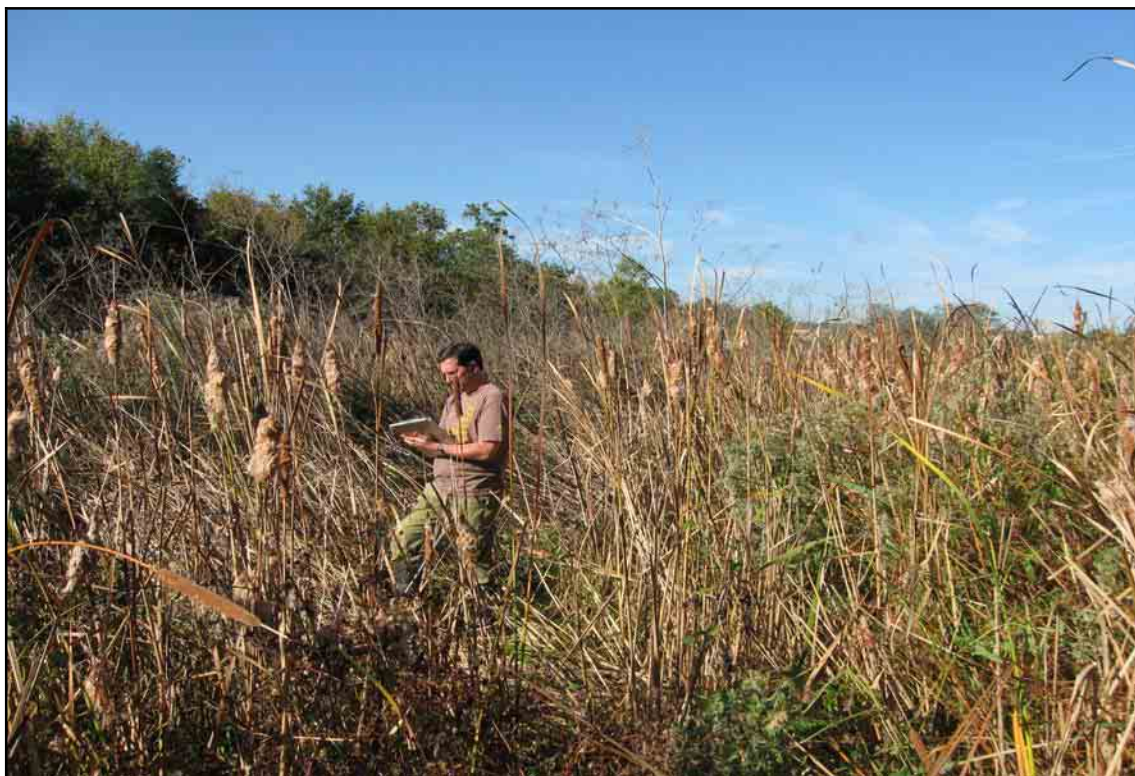
Wetland 5 (W-05) facing south.

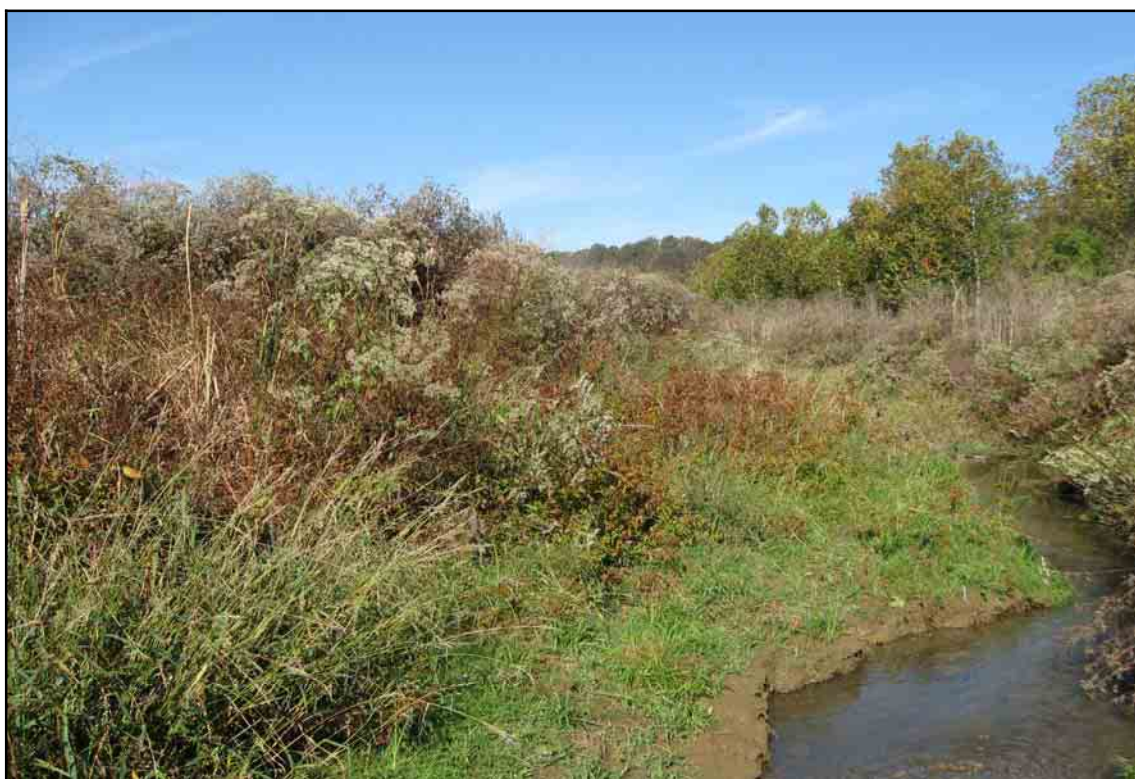
Wetland 6 (W-06) fringe wetland along Penitentiary Branch.

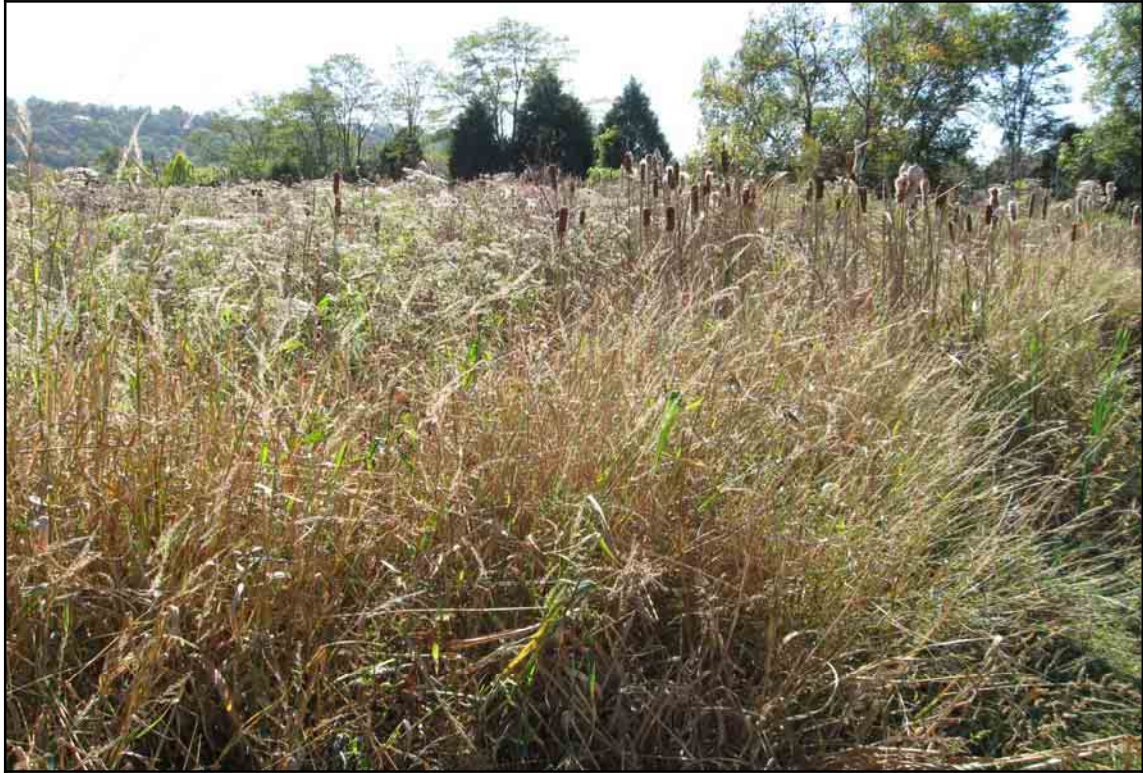
Wetland 7 (W-07) facing south.

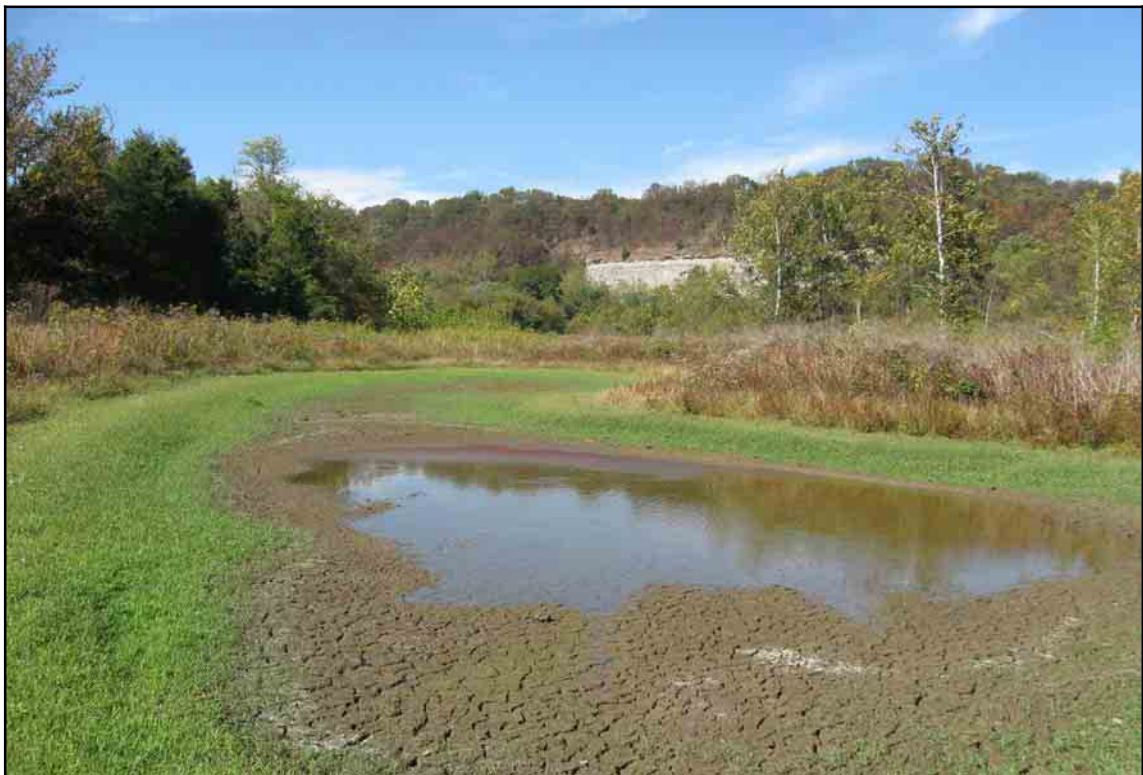
Wetland 8 (W-08) pond margin facing west.

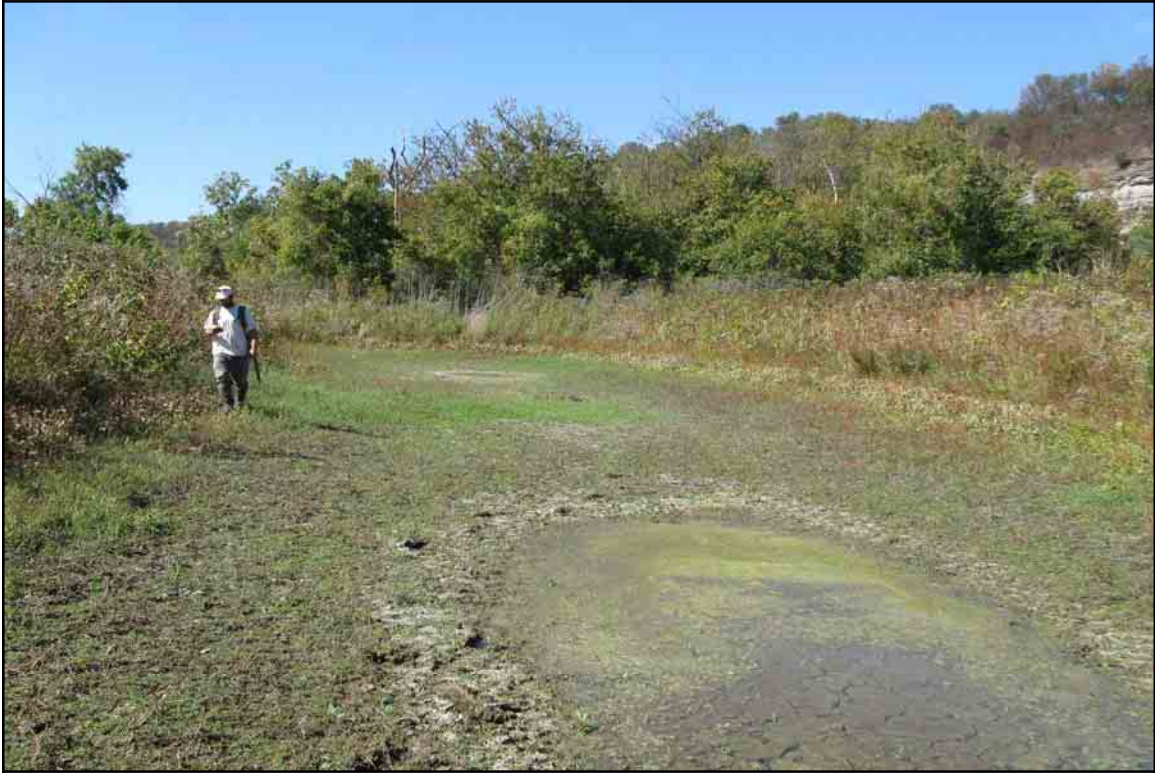
Wetland 9 (W-09) facing west.

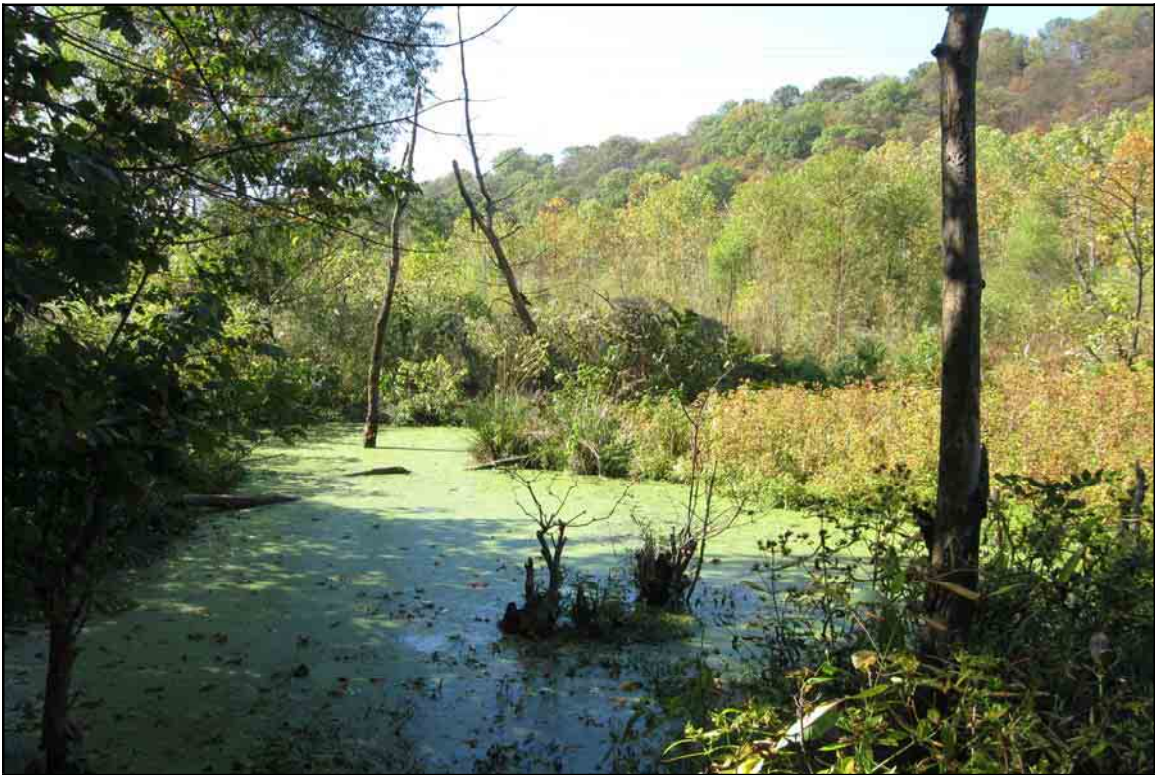
Wetland 10 (W-10) facing west from eastern most edge.

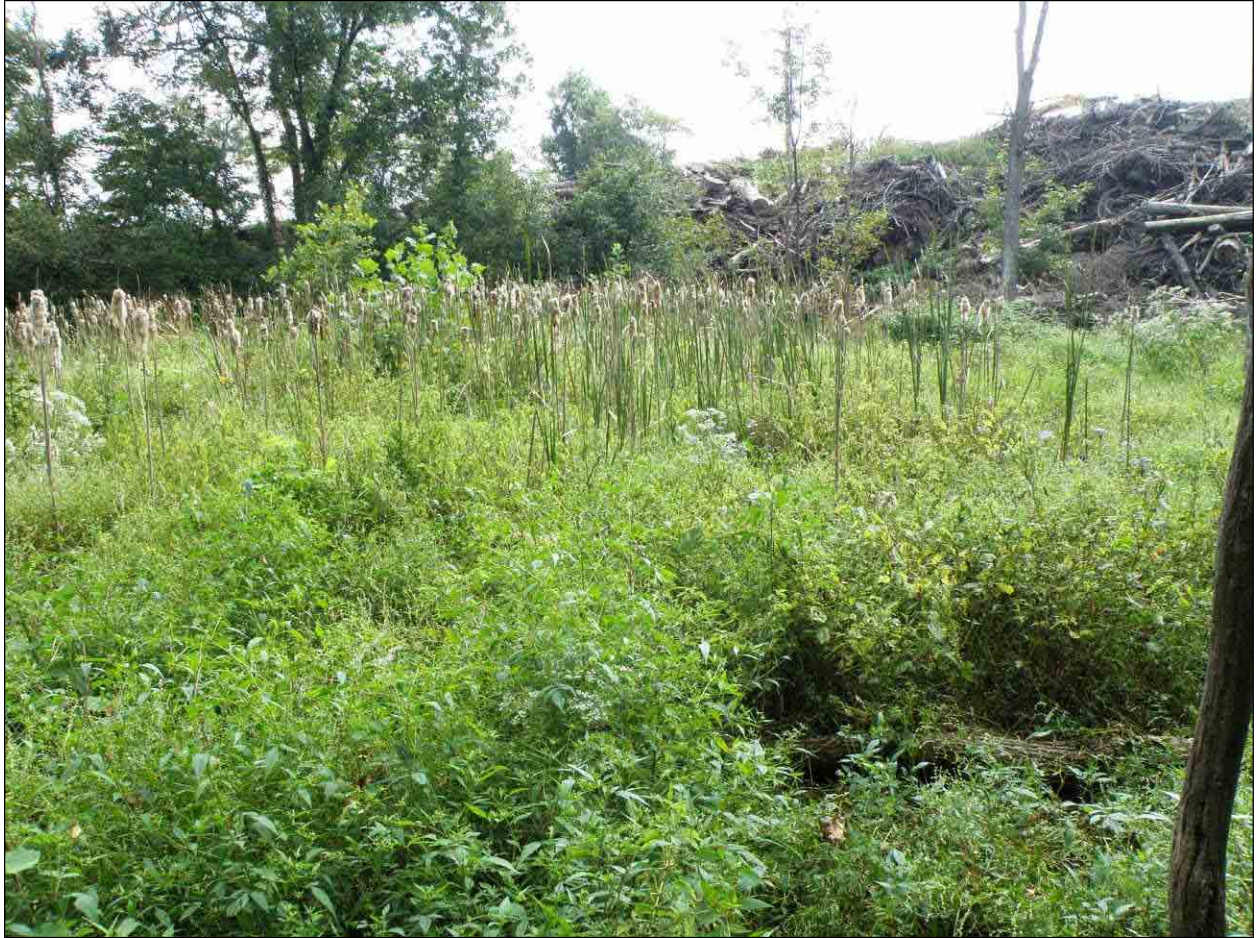
Wetland 11 (W-11) facing southeast from northwestern edge.

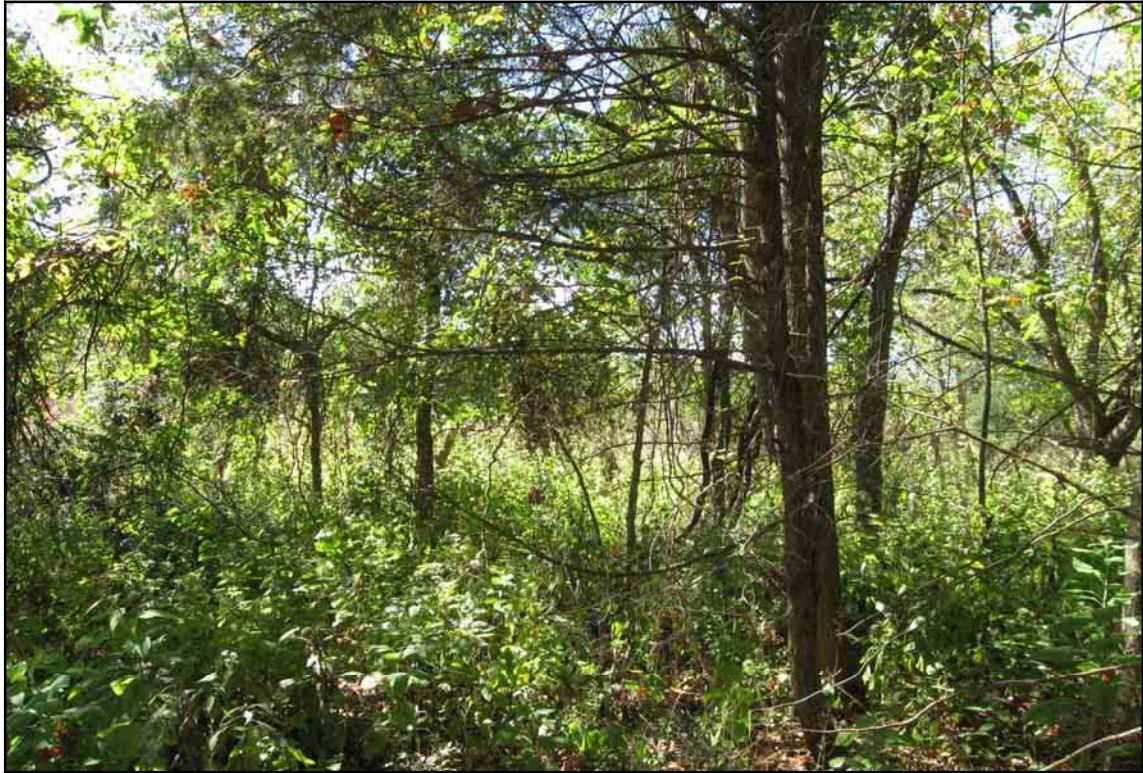
Non-wetland area 1 (#1) west of US 127.

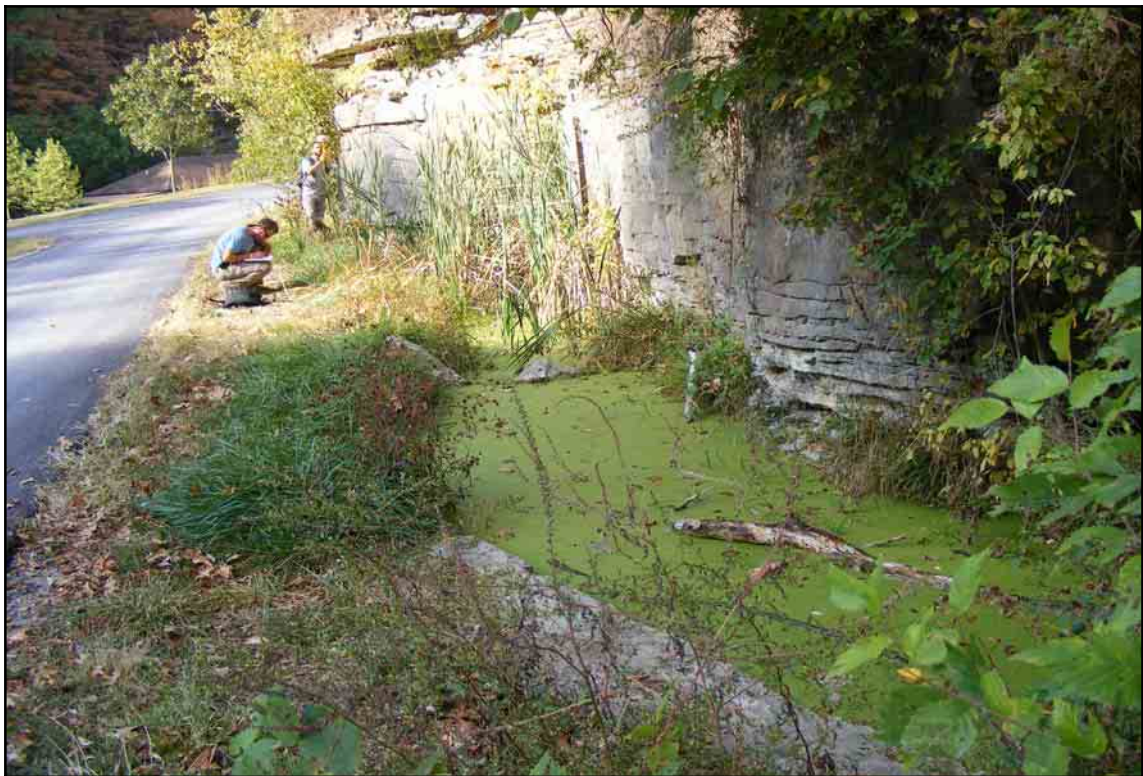
Non-wetland area 2 (#2) east of US 127.

One questionable wetland area was determined to be an atypical situation caused by man-made conditions. According to the methods described in section (D) of the USACE Wetland Delineation Manual (Environmental Laboratory 1987) it was determined that normal circumstances did not exist in this area. Under subsection (4), man-induced wetlands are defined as an area that has developed at least some characteristics of naturally occurring wetlands due to either intentional or incidental human activities (Environmental Laboratory 1987). This area displayed wetland hydrology and hydrophytic vegetation. However, hydric soils were not observed because the bottom of this area was constructed with concrete, making it a man-induced wetland. The USACE Wetland Delineation Manual (Environmental Laboratory 1987) states that all three wetland indicators (soils, vegetation, and hydrology) may be found in some man-induced wetlands, although indicators of hydric soils are usually absent. Step 4 under subsection 4 (man-induced wetlands) states that if hydrophytic vegetation is being maintained only because of man-induced wetland hydrology that would no longer exist if the activity were to be terminated, the area should not be considered a wetland (Environmental Laboratory 1987). Based on the above information, this area is not a jurisdictional wetland (see Attachment 4, non wetland 2; Attachment 6, non wetland 2 data form).

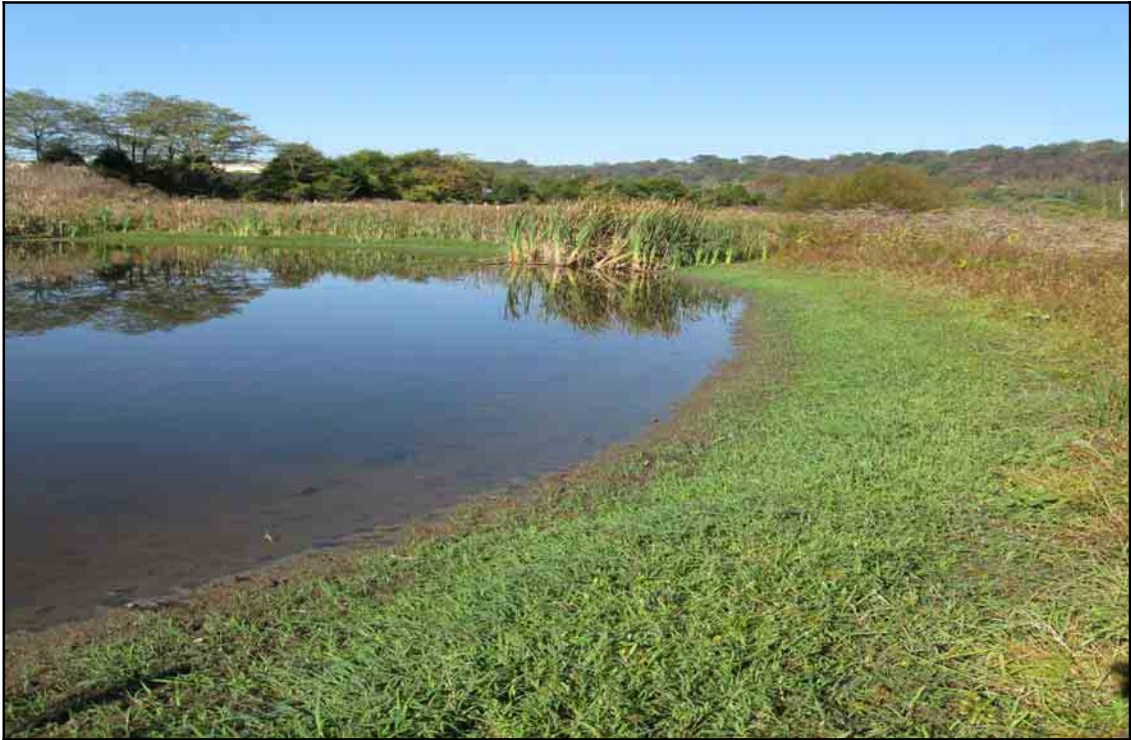
Open water 1 (OW-1) facing west.
